## UPGRADING SE-330 FLASH MEMORY

**NOTE:** This procedure should only be used to upgrade the SE-330 series (including the SE-330AU and SE-330HV) with hardware revisions less than 10. This series can also be identified by the presence of an RS-232 serial port.

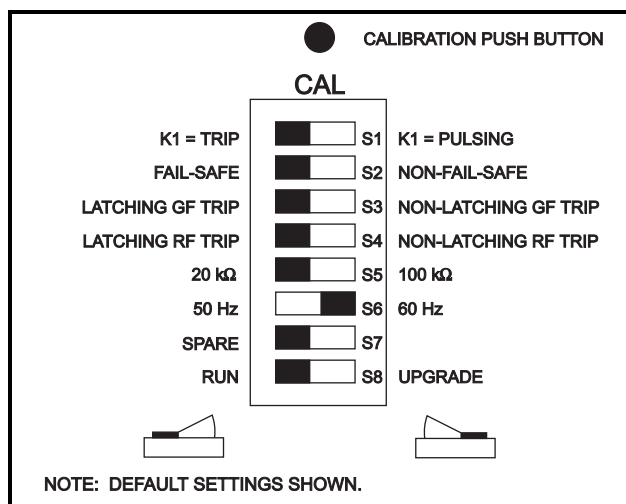
FIGURE 1. Configuration Switches.

1. Run SE-Flash.
2. Select the SE-330 from the list.
3. Select the correct firmware file.
4. Select the COM port you intend to use.
5. If you are satisfied with the summary and your choices, select "Begin".
6. The message "Please set unit to UPGRADE mode now" will appear.
7. Remove supply voltage to SE-330.
8. Set switch S8 (behind access cover on the SE-330 front panel) to UPGRADE. See Fig. 1.
9. Apply supply voltage. The DIAGNOSTIC LED will be on and all relays will be de-energized.
10. Press "OK" to start the upgrade. Wait until complete.
11. Remove supply voltage.

12. Set switch S8 to RUN.
13. Apply supply voltage.
14. Optional: Download and run SE-MON330 (available from [www.littelfuse.com](http://www.littelfuse.com)) to verify the revision number of the new firmware. Exit SE-Flash before running SE-MON330.
